# BELZONA PROTECTS PAPER MILL ROLLER GEARBOX COVER

ID: 1095

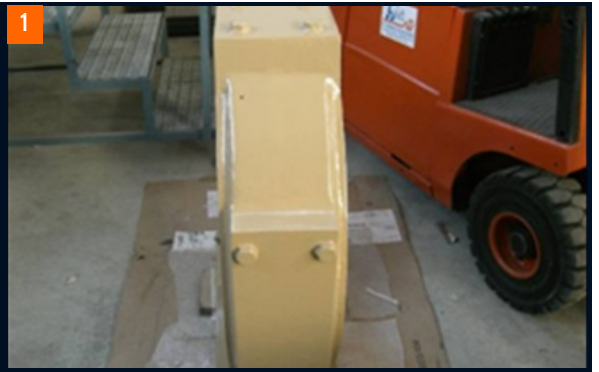
1. First coat of Belzona 5811
2. Second coat of Belzona 5811
3. Finished application
