# BELZONA GIVES SECOND LIFE TO POLYMER CONCRETE TANK

ID: 1097

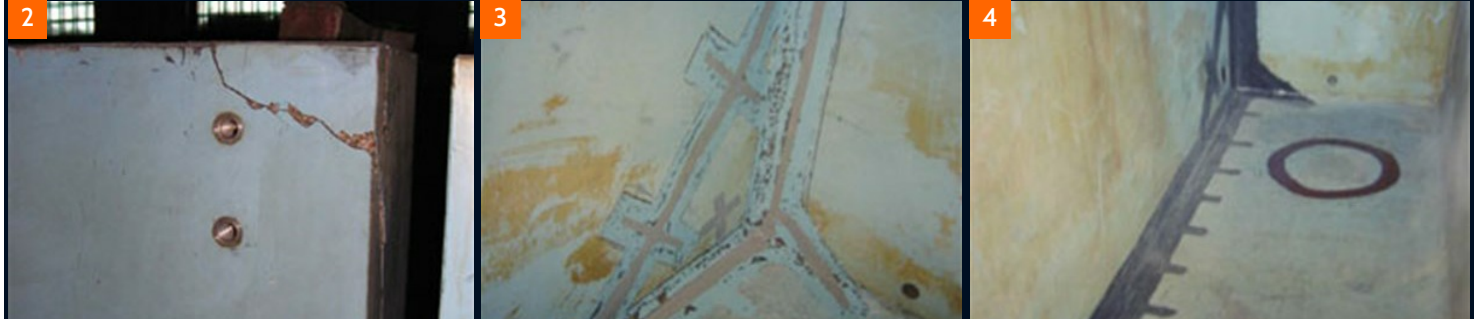
## PHOTOS

Incorrect maintenance caused cracks to develop in several tanks and leakages of acid onto the floor. Every tank costs more than 15000 USD. Two of the tanks lost their integrity as both had large parts of wall broken off and were ready to be condemned.

1. Fatal damage to the tank
2. Another tank is destroyed
3. Belzona 4111 after application
4. Belzona 4341 after application

On the completion of the repairs the tank was tested under load and did not show any traces of leakage. After 3 year operation tank is in excellent condition. Total job took two weeks and customers spent 6000 USD on it.

Belzona 4111 (Magma Quartz) Belzona 4341 (Magma CR4)
