# BELZONA PROTECTS WASTE WATER TANK

ID: 1098

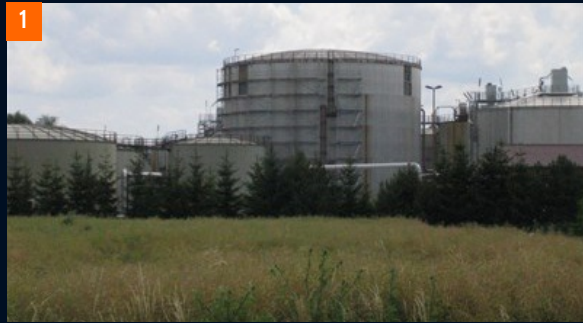
10,600 cubic metre waste water tank with inner surface of 3000m<sup>2</sup> containing waste water from pulp production.

1. 10600cbm tank
2. Welded steel plates during crack testing
3. Rebuilding of pitted surface with Belzona 1121
4. Hot sprayed surfaces with Belzona 5811 before scaffold was taken out
