# BELZONA REPAIRS AND PROTECTS ROOF

ID: 1099

The building is a public sport facility with a roof surface area of 1400m<sup>2</sup>.

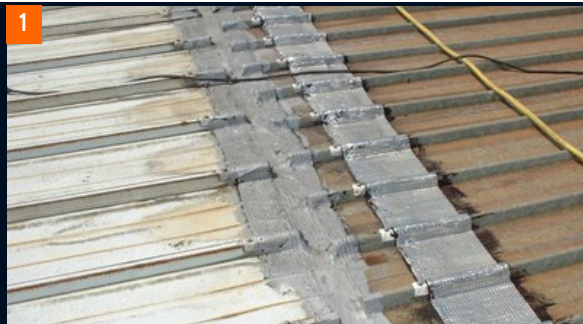
Localised leakage and overall corrosion problem

1. Localised water ingress
2. Repair to the seams
3. Application extended to cover Corroded roof
4. Application completed

Localised repairs carried out in accordance with Belzona Know-How System Leaflet RPA-1. Further corrosion protection achieved by spray application of Belzona® 3111 system.

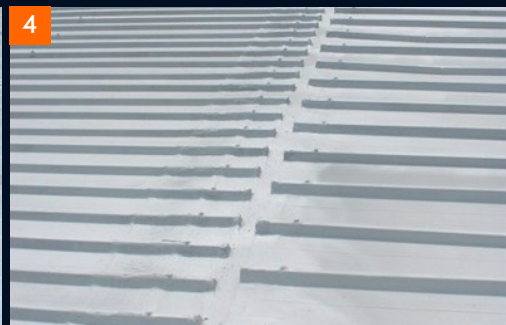
Belzona solution stopped the water ingress into the sports facility and also gives corrosion protection to the overall steel surface.
