# BELZONA REFURBISHES RAW JUICE HEATER

ID: 11

Raw sugar juice heater

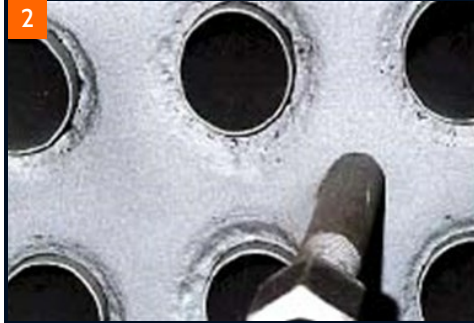
1. Juice heater.
2. Erosion around tubes.
3. Forming technique used to rebuild and seal around tubes.
4. View of tube sheet surface after one year in service.

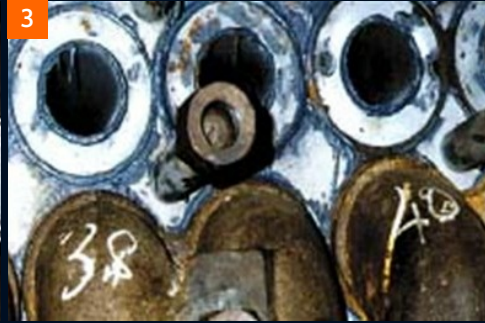
Erosion/corrosion of around tubes on tube sheet surface. Operation of heater proved ineffective and presented a safety hazard.
