# BELZONA PROTECTS EVAPORATORS IN DISTILLATION UNIT

ID: 110

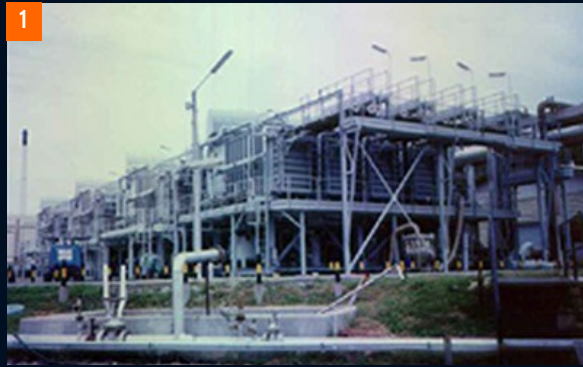
1. General view of the 4 Distiller units.
2. Work underway inside the Evaporator. Note low temperature lighting used to minimise air temperature.
3. Belzona 1391 applied to base and 30cms up side of all steelwork in unit.
