# BELZONA EXTENDS LIFE OF CHILLER

ID: 1103

Three chiller units for air conditioning of terminal buildings.

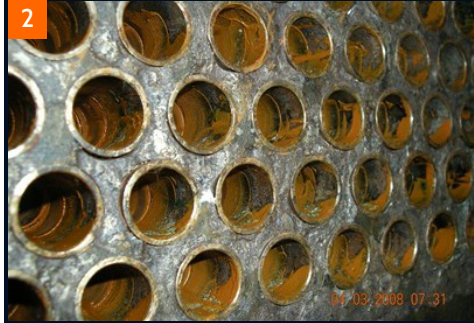
1. General view
2. Close up of erosion on tubesheet
3. Steam cleaning
4. Completed application

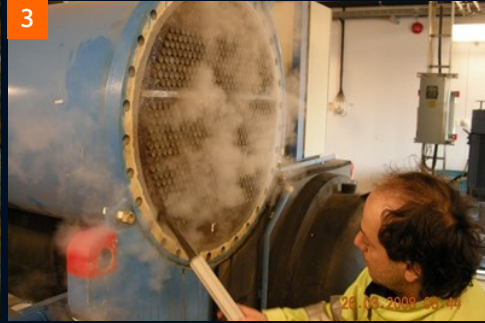
Corrosion on tubesheets (4) from one of the chillers was noticed in 2005. Cooling water comes from a local lake which together with galvanic effects was the cause of the corrosion.

In 2008, the chillers were inspected and the two untreated ones were found to have severe erosion, whereas the Belzona protected one was still in excellent condition.
