# BELZONA EXTENDS RUBBER PUMP LINER LIFE

ID: 1104

Warman pump circulating Gypsum slurry

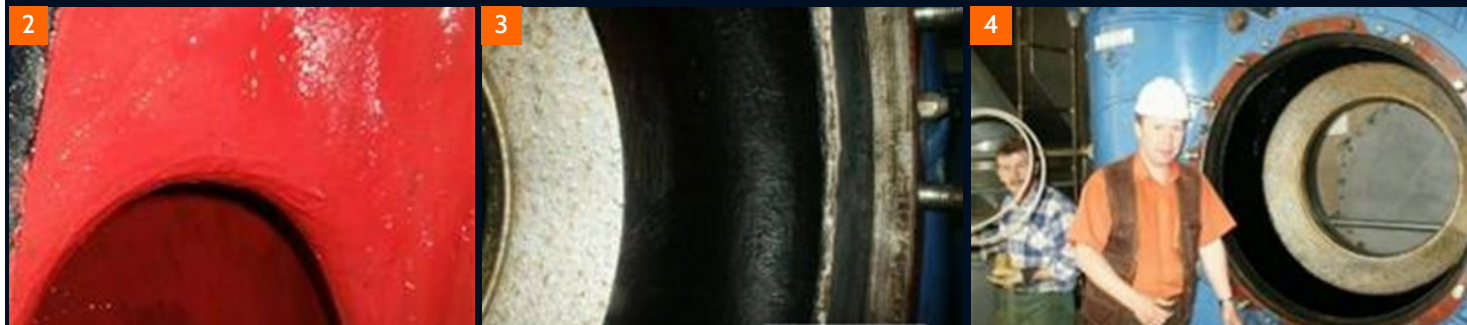
The rubber liner had limited life (up to 5 years). New liner cost 40,000 EUR

1. General view of the pump
2. First coat applied
3. Second coat
4. completed application

Application was carried out in accordance with Belzona Know-How System Leaflet CEP-3.

New liner costs 40,000 EUR. Belzona coating cost 3,000 EUR and after 3 years in service shows no significant wear.

Belzona 2121 (D&A Hi-Coat Elastomer)
