# BELZONA TEMPORARY SOLUTION TO A SERIOUS PROBLEM STILL IN SERVICE 10 YEARS LATER

ID: 1106

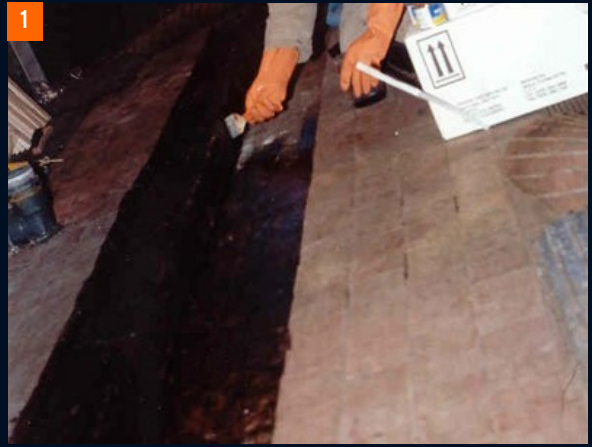
1. The cracked membrane was repaired with two coats of Belzona Elastomer
2. A pony wall was built using Belzona 4131
3. The entire rebuilt area was overcoated with two coats of Belzona 4311
4. View of the repair taken 10 years later showing it to be still in excellent condition

Application was carried out in accordance with Belzona Know-How System Leaflets FPA-3, -5 & -6. Rubber membrane was sealed with Elastomer and low retaining wall (pony wall) was constructed.

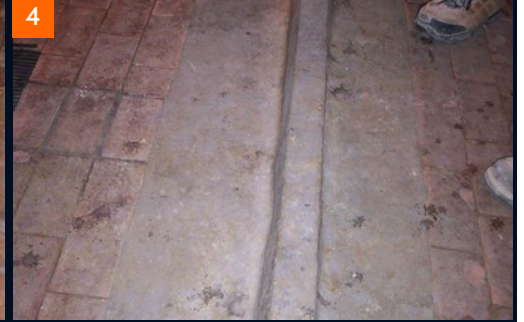
This application, though deemed temporary at the time has been in service for 10 years without the need for any maintenance.
