# BELZONA PROTECTS BLOWER HOUSING FROM CHEMICAL ATTACK

ID: 1108

Zinc Smelter - British Columbia, Canada

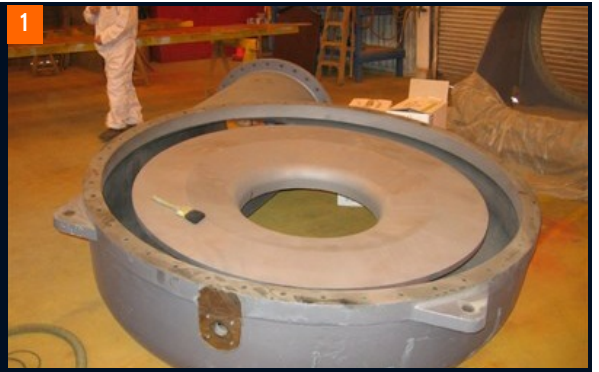
1. The blower housing grit blasted and ready for application
2. The backing plate grit blasted and ready for application
3. Blower housing with 1st coat of Belzona 4341 (Red) applied
4. Blower housing with 2nd coat of Belzona 4341 (Black) applied
