# BELZONA PRODUCTS USED TO SEAL LEAKING TANK

ID: 1109

Leaking concrete stock tank

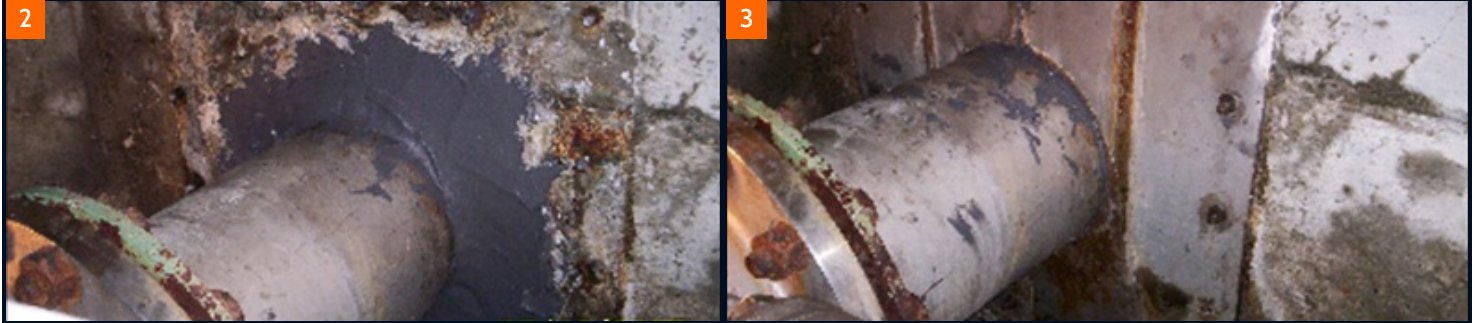
Mill had experienced a constant leak between the concrete wall of the stock tank and the steel outlet pipe

1. Preparation of both the concrete and metal surfaces underway
2. Belzona 1311 forced into the gap between the pipe and concrete
3. The back of the metal plate was coated with approximately 1/4 inch of Belzona 1311 before it was bolted against the wall and the excess material squeezed out was wiped away

Application was carried out using modified versions of Belzona Know-How System Leaflets TCC-1 and VPF-11a. Bolted doubler plates were used to help form seal.
