# BELZONA BECOMES A PERMANENT FIXTURE ON PUMPS

ID: 111

Main cooling water pumps

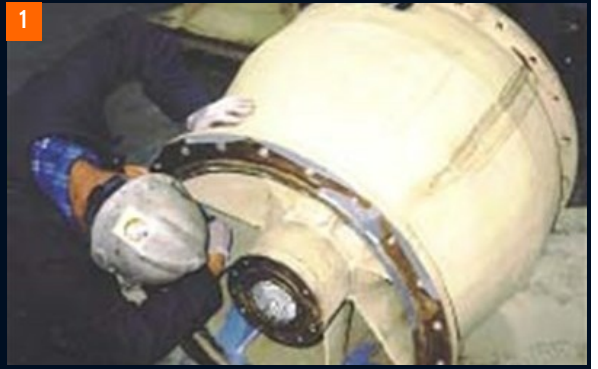
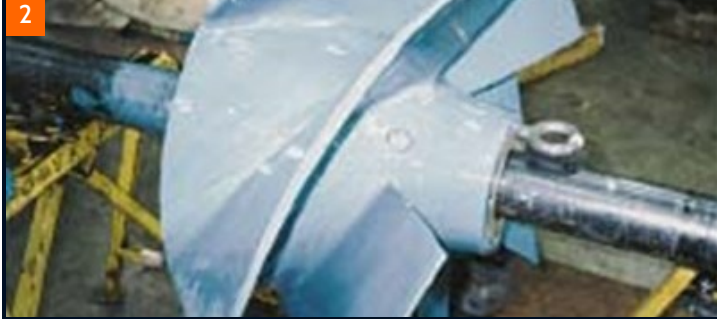
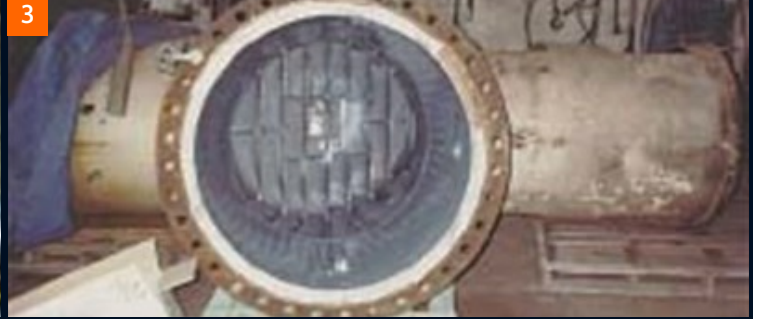
Application of Belzona 1341 to a diffuser bowl begins. Finishing touches to an impeller shown here. Flow diverters and all internal components were protected with Belzona 1341.

Three pumps were rebuilt in 1992. In 1995, one pump was pulled out of service, and after three years of operation, the Belzona® 1341 coating was still in excellent condition and required no touch-up.
