# BELZONA SCREED REBUILDS DETERIORATING FLOORS

ID: 1111

Supermarket, British Columbia, Canada

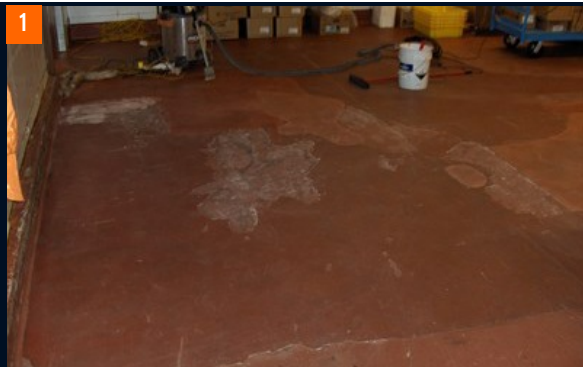
Water trapped beneath the red floor coating was causing odor and health concerns.

The original red epoxy coating was delaminating.

1. General view of problem floor showing delamination areas
2. Preparation of floor in progress using a Vacu-Grinder
3. Application of Belzona 4131 Magma Screed in progress
4. Completed application
