# BELZONA SCREED RESTORES DETERIORATED FLOORS

ID: 1112

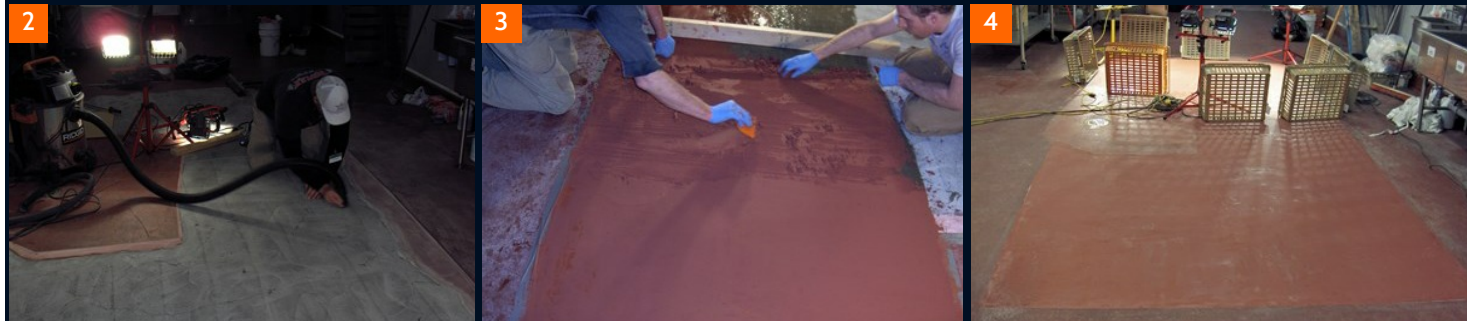
## PHOTOS

Water trapped underneath the failed coating was causing odour and health concerns.

The red epoxy floor coating was delaminating.

1. The delaminated coating was removed with scrapers
2. The area was ground with a Vacu-Grinder
3. Application of Belzona Magma Screed in progress
4. Completed application with heat lamps in place.

Application was carried out in accordance with Belzona Know-How System Leaflet FPA-1.

Heat lamps were used to accelerate cure to ensure area ready for use following day.

Belzona Magma Screed provides hard wearing floor covering that was applied overnight so causing minimal disruption to the store.
