# BELZONA REBUILDS WASTEWATER PUMP IMPELLER

Pump impeller handling raw water.

Water treatment plant, Des Moines, Iowa U.S.A.

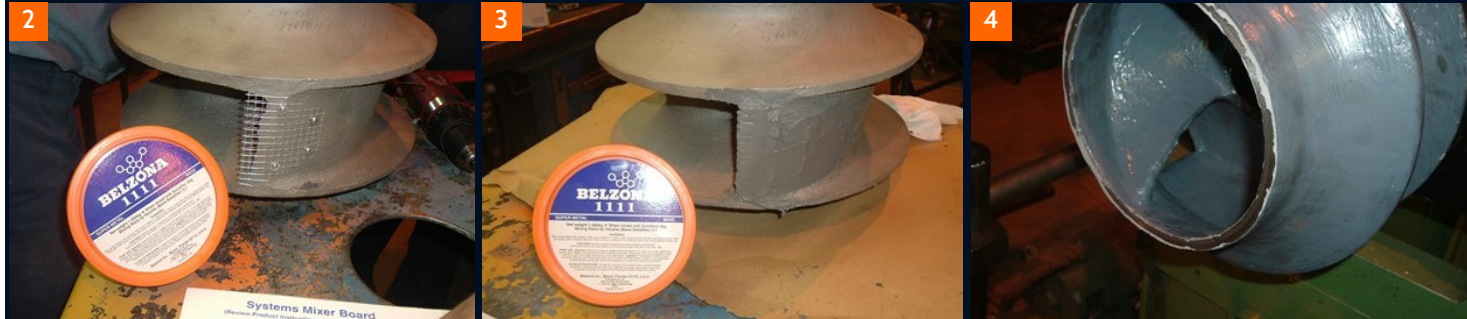
The impeller was badly eroded and damaged due to grit and solids running through the pump

1. Damaged impeller after being baked and grit blasted
2. Impeller with wire mesh in place to support Belzona and help form profiles
3. Profiles restored with Belzona 1111
4. Rebuilt impeller being balanced

Belzona was chosen to rebuild the impeller at a fraction of the replacement cost.

Belzona 1111 (Super Metal) Belzona 1321 (Ceramic S Metal)
