# BELZONA PROVIDES LONG TERM REPAIR TO DEMIN PLANT FLOOR

ID: 1117

Water treatment plant floor

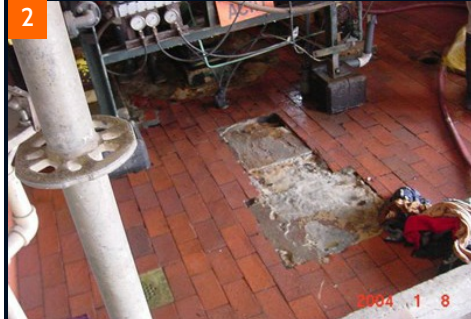
Old acid resistant bricks suffered chronic damage from acid and caustic leaks. Repair needed to restore floor integrity.

1. Demin floor damage
2. Floor cleaned and prepped
3. Finished floor in January 2004
4. Demin floor June 2008

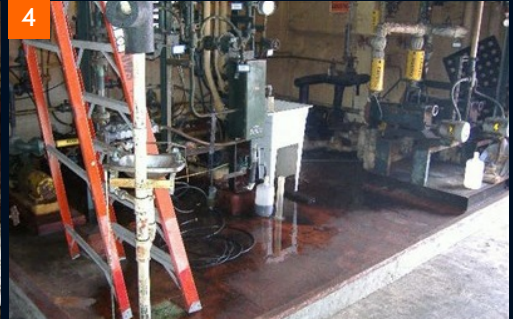
Client needed a solution to a containment problem. Area to be protected was uneven and rough. The mortar-like consistency of Belzona® 4181 made it ideal for this repair. After almost 4 1/2 years, application looks very good with no visible damage to the floor.
