# BELZONA PROVIDES LONG LASTING PIPE SUPPORTS

ID: 112

Product and services pipelines at oil terminal. There are five separate pipelines of differing diameter.

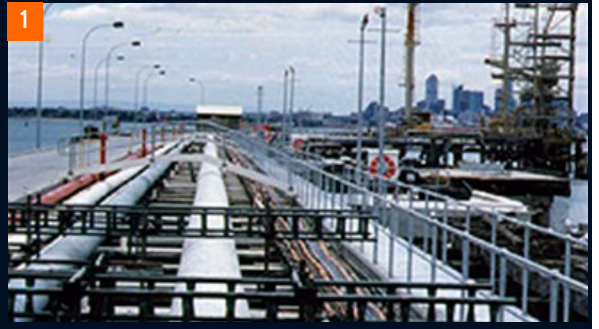
Severe corrosion of original pipe supports and pipe in way of support points.

1. General view of terminal
2. Typical corroded state of original supports
3. New saddle bonded in place prior to re-painting of the pipe

New pipe saddle supports and wear pads were bonded in place in accordance with Belzona Know-How Leaflet VPF-15.

Welding of new supports was not possible due to unloading of LPG and oil from tankers at regular intervals. Tests showed Belzona® 1121 provided corrosion resistant bond that required 25 tons to remove bracket.
