# BELZONA HELPS UNDER FIRE

ID: 1122

Bauxite Bin and Raw Mill

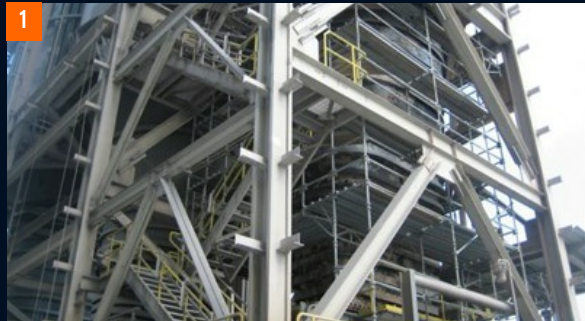
This is a very corrosive environment due to the nature of the raw material and the high temperatures used in the process led to serious corrosion on the plant. A serious fire, However, accelerated the situation and the bauxite bin could not be used anymore, forcing a shutdown at the plant.

1. Bauxite Bin After The Fire
2. Raw Mill after application of Belzona 3921
3. Bauxite Bin during first coat of Belzona 5111
4. Bauxite Bin after completion of the application
