# BELZONA RESTORES STEEL MILL FLUME

ID: 1129

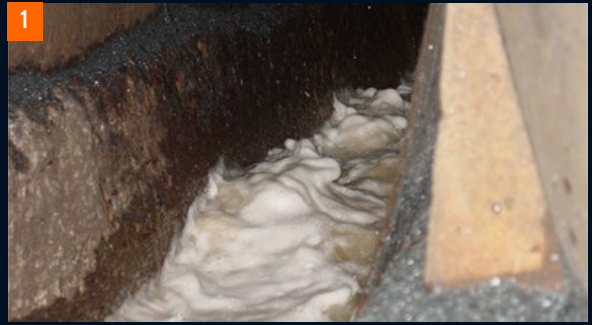
Highly abrasive waste material was rapidly eroding the flume, carving out a larger cross-sectional area than original designed. Flow velocity dropped as a result and the flume was not longer functioning as designed thus allowing build up of waste within the flume.

1. Trough prior to surface preparation
2. Trough profile reformed with Belzona
3. A further quarter inch of Belzona 4111 applied
4. Trough fully coated with Belzona 1812
