# BELZONA WATERPROOFS CONTROL ROOM ROOF

ID: 113

Flat concrete slab roof over control room

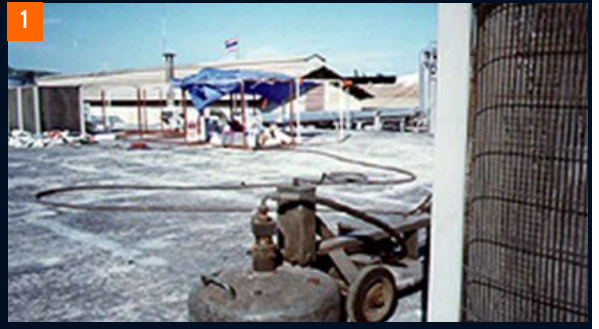
1. The pneumatic scabbler used to prepare the roof surface
2. Application underway with part of the roof conditioned and part coated with Belzona 3111
3. The completed application. Note the seamless finish achieved over the many equipment supports

Application was carried out in accordance with Belzona Know-How Leaflets RPA-1, RPA-2, RPA-6, RPA-8, RPA-10 and RPA-11.
