# BELZONA PROTECTS CHEMICAL CONTAINMENT AREA

ID: 1135

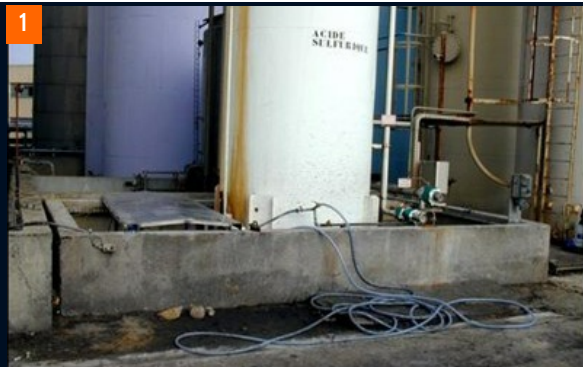
Heavy deterioration of the concrete due to leakage and contamination during maintenance operations. The integrity of the structure was compromised.

1. View before repairs
2. View of the tank supports
3. View after shimming
4. Application completed with Belzona 4311 applied

Application was carried out in accordance with Belzona Know-How System Leaflet TCC-15. Special attention given to shimming and protecting base of support steelwork.
