# BELZONA SEALS LOCAL ROOF PROBLEM

ID: 1139

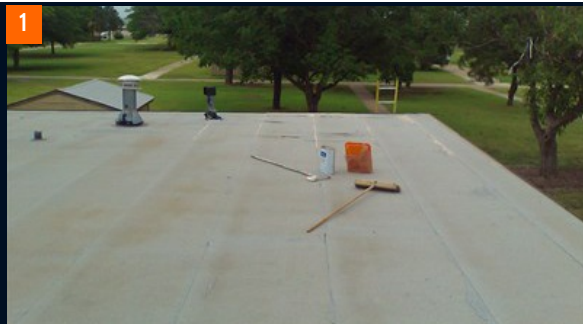
Building was being refurbished inside and the roof was leaking in the corner halting the interior work.

1. Leaking section of roof after washing and drying
2. Belzona 3911 (PSC Conditioner) applied
3. First coat of Belzona 3111 incorporating reinforcing sheet applied
4. Completed roof repair and leak free

Application was carried out in accordance with Belzona System Leaflets RPA-1,2 & 7. A fully reinforced Belzona® 3111 system was applied to the corner of the roof where leaks were identified.
