# BELZONA MENDS HOLE FROM ASH DUST

ID: 114

Fan housing

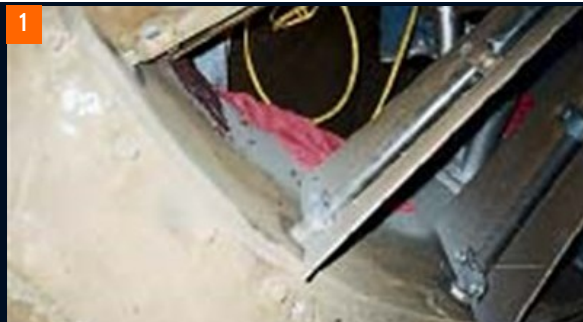
Hole worn through metal caused by abrasive ash dust.

1. Work commenced at night. 2. The hole is mended with Belzona 1811. 3. Close-up view of the repaired area.

Application was carried out in accordance with Belzona Know-How Leaflets FBC-4 and FBC-5.
