# BELZONA SEALS SKYLIGHTS ON JET HANGER

ID: 1140

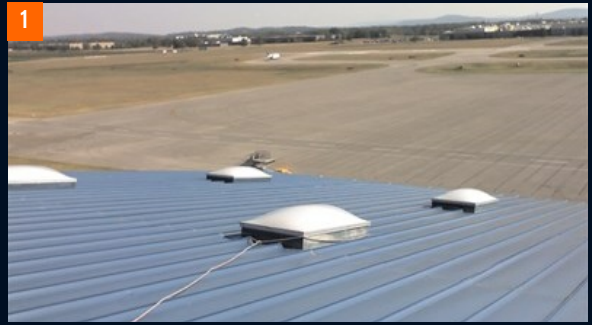
The roof of the hanger has 16 skylights and each one leaked. Several earlier attempts to seal skylights proved futile.

1. Skylights with runways in background
2. Taped off and ready to coat
3. Belzona 3111 1st coat going on
4. Finished job. No leaks - no problems!
