# BELZONA REFURBISHES MILITARY DOG KENNELS

ID: 1142

An easy to clean, hygienic non slip coating required.

Floors and walls in dog kennels.

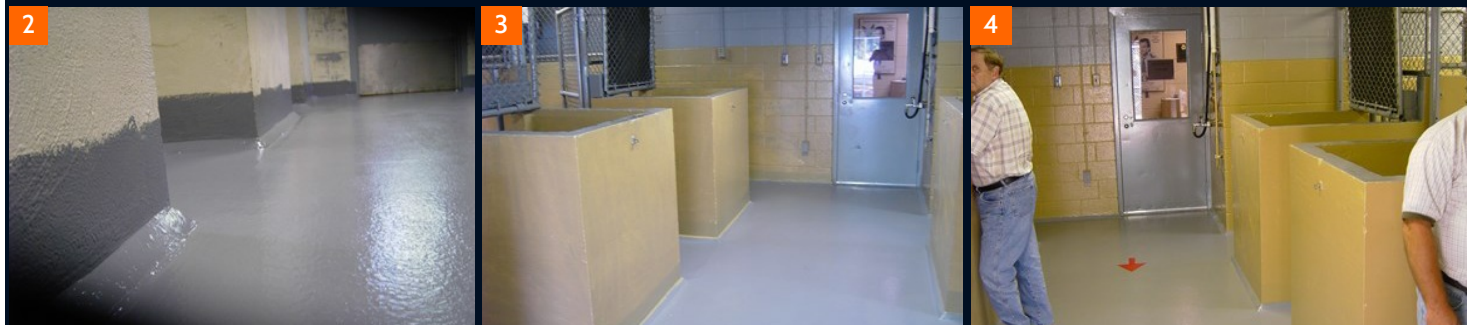
1. Prepped and ready to coat
2. Floor and coves covered
3. Almost complete, walls being coated
4. All done! Ready to turn over to the owners

To create a non-slip surface that did not damage paws, different aggregates were tried before settling on a non-standard Belzona one that was found to be ideal. Coves between wall and floor were formed and Belzona® 5111 provided stain resistant finish.
