# BELZONA CALLED TO FIX FAILED COATING

ID: 1143

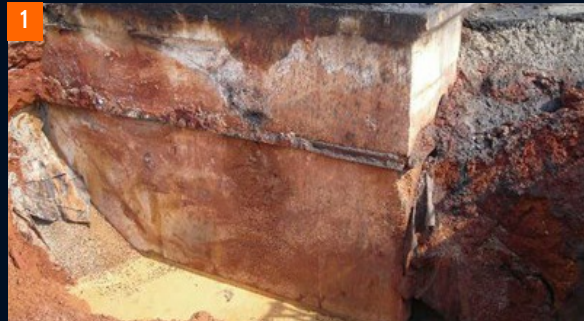
Small leak in the wall of an acid pit. The leak was below ground and the pit walls had to be excavated, shored up, scaffolding, extreme safety measures involving several contractors...all due to a competitors coating failure.

1. The size and scope of a small Leak
2. The failed coating
3. External view after preparation
4. Finishing touches

The repair required a form built on the outside so Belzona® 4111 & 4141 could be packed into the hole. Several smaller holes were discovered inside and out. Each repair was then covered with 2 coats of Belzona® 4301.

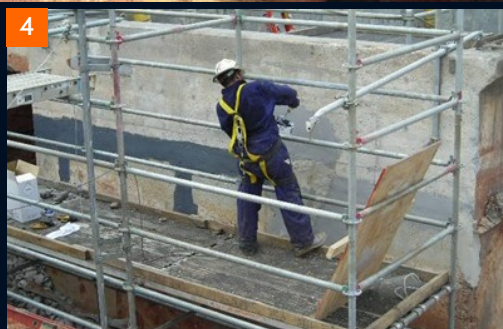
The leak turned out to be a hole measuring 36" x 48" and cut completely through the 8" thick wall. Rebar had to be tied back in and the wall needed to be rebuilt to specification. The plant was still in operation, so the acids were diverted to holding tanks and taken off site for processing...an expensive and tedious process.
