# BELZONA SEALS UPPER FLOOR PUMP ROOM

ID: 1145

Pump room at hospital positioned on floor above computer room.

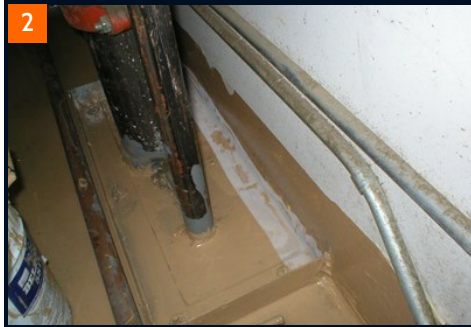
Copper pipes leaking water on the floor was leaking through the concrete to the lower level.

1. The pump room showing the pipes that keep leaking
2. Reinforcement tape used for edges
3. Back of pump room
4. Finished floor

After washing and removing dirt from floor Belzona® 5811 was used to coat the entire floor plus 6 inches up the wall to completely encapsulate the area and to form a containment area.
