# BELZONA REPAIR TO CONCRETE STOCK CHEST

ID: 1146

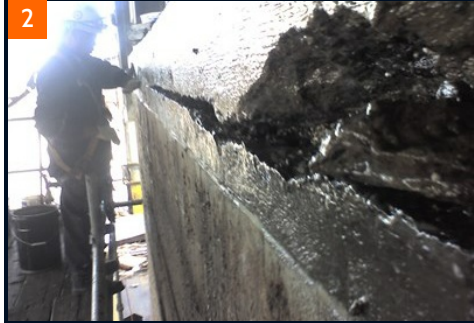
The top not only lifted, it blew chunks out of the sides all the way around. Job was to fill in the voids created by the stock and to seal the edges against further leaking.

Concrete block tank holding stock being fed to the #1 Paper Machine. It has a pressure release valve to allow blow-by in case of emergencies and it failed. The pressure grew to the point that the solid, reinforced concrete lid lifted and stock blew out the sides.

1. View of the Damage from below
2. Area being prepared and void packed
3. Work underway
4. Finished application

This application was carried out in accordance with Belzona Know-How System Leaflet TCC-9 and WPA-4. The area was grit blasted to remove stock and prepare the concrete. Deeper areas were filled with Belzona® 4141 and Belzona® 4111 was used over the entire outer surface to ensure containment.
