# BELZONA REPAIRS BROKEN INSULATORS

ID: 1147

Electrical Insulator in a distribution sub-station.

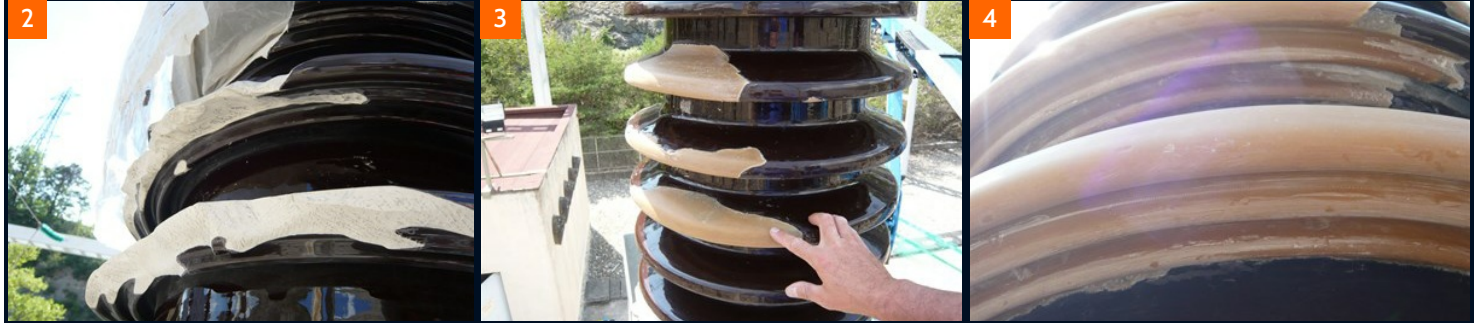
Broken insulator, compromising safety on site.

1. General view of the sub-station
2. Broken insulator
3. Repair completed
4. Close up showing exact reproduction of the original profile

Pattern for the broken area taken from sound area using Belzona Elastomer. This then used to mold Belzona® 8111 to re-create original profiles

The repair was done on site by the application team, who completed the job in a few hours.
