# BONDING FAIRLEADS WITH BELZONA

ID: 1148

37 Meters long Yacht

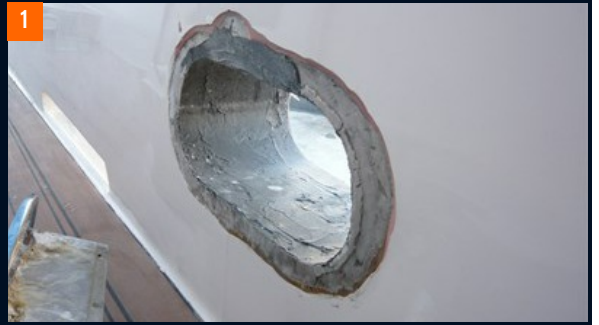
1. Fairlead pocket
2. Fairlead before application
3. Application underway
4. Fairlead clamped in place during the cure process

Fairleads have been dismantled in order to realise repairs to the hull. A rebuilding and bonding material was then necessary to fill gaps when fairleads were replaced.

The pourable chocking option usually considered by the customer could not be applied in this situation due to the thickness of adhesive required. Belzona® 1111 has no limitation in thickness when applied in such an environment,
