# BELZONA PUMP COATING LOOKS EXCELLENT AFTER 7-1/2 YEARS

Centrifugal pump

Industrial Wastewater Treatment Plant in Northwest Florida

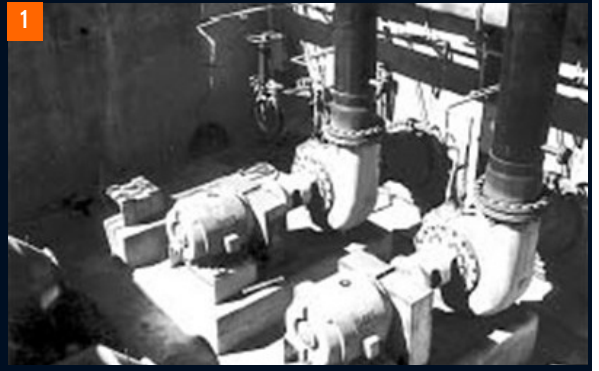
1. External view of the pit and pumps
2. Inside view of pump casing shows worn area of spool. The remainder of Belzona 1321 coating, done 7 1/2 years ago, is in excellent condition.
3. Worn areas touched up with Belzona 1311/1321 system
