# BELZONA TO THE RESCUE FOR HIGHER LEARNING

ID: 1158

University Central Energy Plant -  
Laramie, Wyoming USA

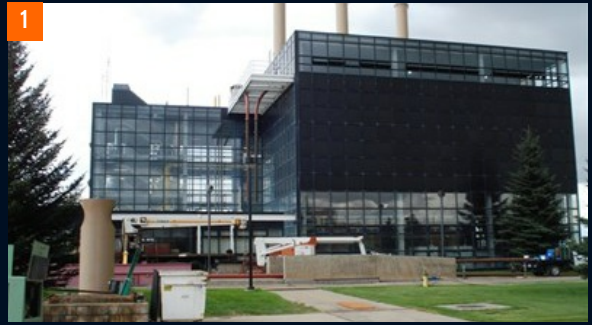
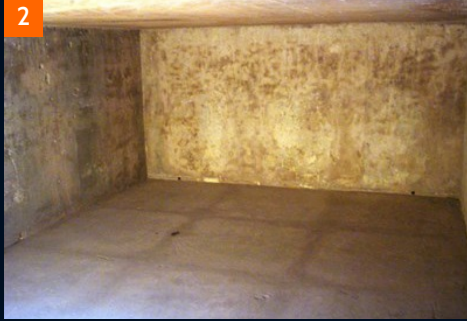
After one short year in service, the original coating was delaminating in large sheets exposing the concrete and rebar to the corrosive action of the hot condensate.

1. Central energy plant
2. Condensate tank after abrasive blasting
3. Belzona 1391 after pinhole testing
4. Belzona application two years later requiring minor touchup due to substrate degradation

Belzona® 1391 and Belzona® 1511 were applied in accordance with a modified version of Belzona Know-How System Leaflet VPF-2.

The original failed coating was discovered with only four days remaining in the annual shutdown. Belzona was easily able to recoat the tank in this limited timeframe and to date has given two years of trouble-free service.
