# BELZONA CONTAINER SHIP RUDDER REPAIRS

ID: 116

Very severe erosion/corrosion of steel components of the ship's rudder

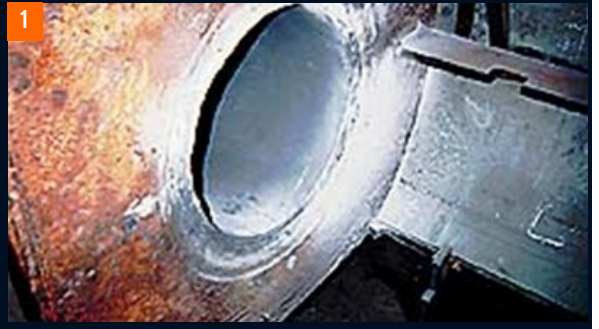
1. Pintle pin bore after molding, 95-99% contact per ABS Surveyor
2. Rudder being installed on ship after pintle pin repairs
3. Rudder stock bore with Belzona 9411 (Release Agent)

The application was carried out in accordance with Belzona Know-How Leaflets SOS-3 and MPT-1.
