# BELZONA 4181 SOLVES NEUTRALIZATION PROBLEM

ID: 1161

Secondary containment area for 98% Sulfuric acid

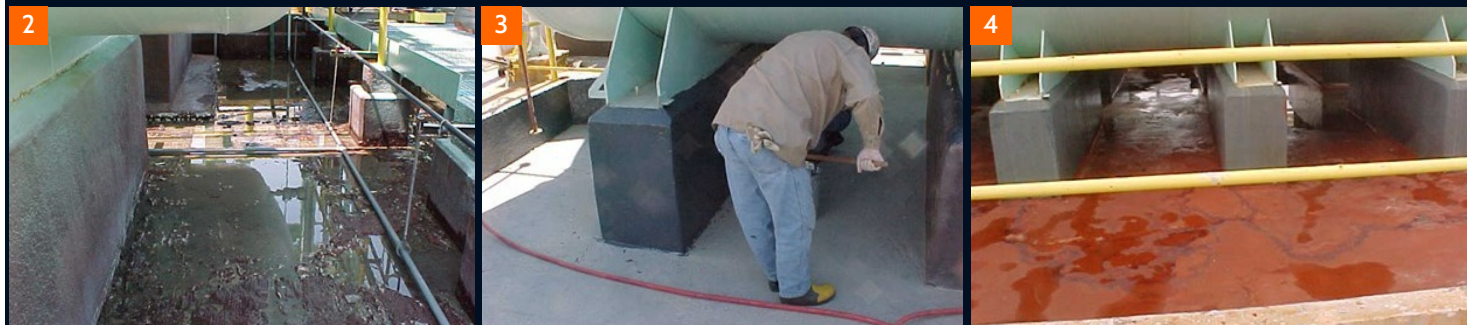
Spill of 98% sulfuric acid was neutralized with caustic. The exotherm badly damaged the coating applied 2 years previous.

1. Overview of the sulfuric acid containment area
2. Deteriorated coating after the caustic was added to the acid spill
3. New concrete poured and pedestals coated with Belzona 4311
4. Finished project with Belzona 4181 and perfect after 8 years

Damage concrete removed and 3 inch of new concrete poured to level base.

Belzona® 4181 used on floor and Belzona® 4311 on walls.

The plant had used Belzona® 4311 successfully in several areas of the plant. Due to the high temperature qualities of Belzona® 4181 it was selected to coat the containment floor in case caustic was again used to neutralize spills.
