# BELZONA PROTECTS DIGESTER

ID: 1162

Digester producing Methane during sewage treatment.

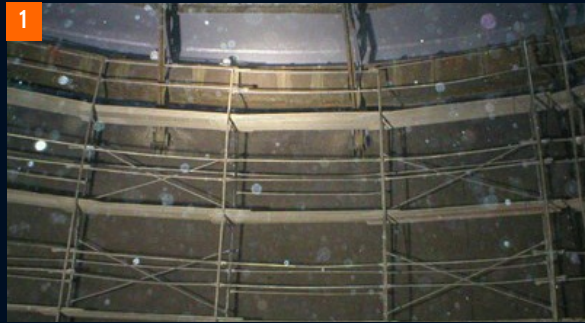
Severe corrosion occurring in vapour space at top of tank on walls and underside of the roof. Also internal pipework being attacked.

1. Top of digester walls coated after grit blasting
2. The pipes waiting to be coated
3. Tank top was also coated with Belzona 5811

Application was carried out in accordance with Belzona Know-How System Leaflet TCC-5.

Belzona 5811 (Immersion Grade)
