# BELZONA SAVES MORE THAN 1 BILLION US DOLLARS

ID: 1165

Diffuser end section from main intake lift pump station handling highly saline sea water.

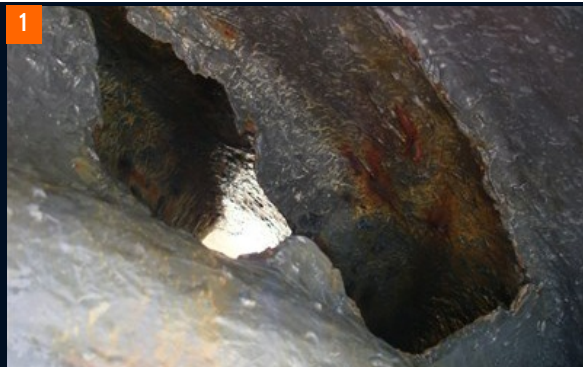
Extreme erosion & corrosion of the internal body. Fifteen vanes badly eroded.

1. Body & Vanes severely damaged
2. Application team at work after Blasting and Sweet Water washing for 6 days to remove heavy salt contamination
3. Final touch-up
4. Smooth operation after 2 months, pumping 18,000 Cu.m/hr

Application was carried out in accordance with Belzona System Leaflets CEP-1, CEP-2, CEP-3, CEP-4, CEP-5 and CEP-6.
