# BELZONA RECLAIMS AND PROTECTS SULFURIC ACID BUND

ID: 1166

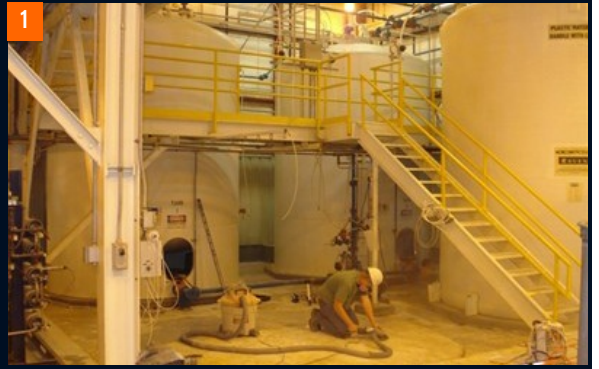
1. Overview of the acid containment area
2. View of the damaged concrete
3. View of area rebuilt and resurfaced
4. Completed job after coating with Belzona 4311

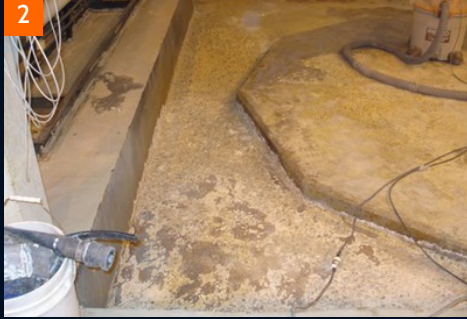
Previous product used gave limited results. Extensive rebuilding of the concrete was needed to allow the containment area to drain to the center sump. This to be followed by an overall protective coating.

Application was carried out in accordance with Belzona Know-How System Leaflet TCC-9 & 15. Concrete was rebuilt to create falls to central sump. All area then protected with Belzona 4311.
