# BELZONA SAVES PUMP FROM THE SCRAP HEAP

ID: 1168

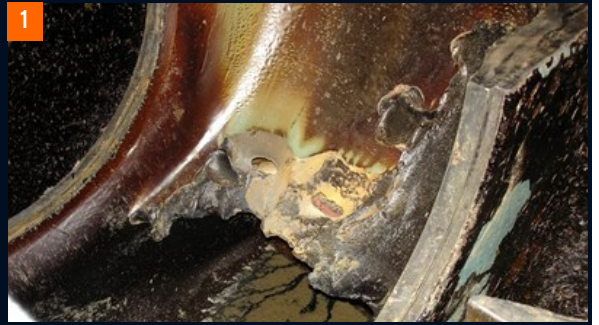
Bad injectors had caused Sulfuric acid not to mix well with paper stock and pump was badly eroded. Cut-water on discharge was eroded away and bowl was severely pitted. Holes through pump bowl. After inspection, injectors were moved downstream.

1. Pump before repair
2. Cut-water rebuild finished
3. Completed application
