# BELZONA GIVES SPIRAL CASING AND VANES NEW LEASE OF LIFE

Spiral casing and vanes

Hydroelectric Power Station in Japan

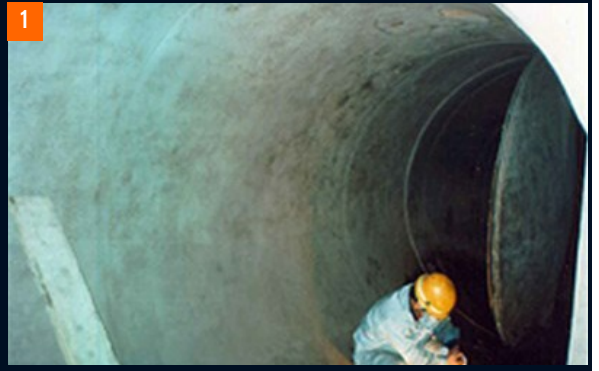
Erosion/corrosion caused by river water.

1. Surface preparation underway in the spiral casing
2. Casing coated with Belzona 1341
3. Application completed by coating vanes

In accordance with Belzona Know-How Leaflet CEP-3. The casing and vanes were blast cleaned and the existing lining material (tar epoxy) peeled off. Belzona® 1341 was applied by airless spray. The coating was then tested for pinholes.
