# BELZONA PROTECTS DISULFIDE SEPARATOR DRUM

ID: 1170

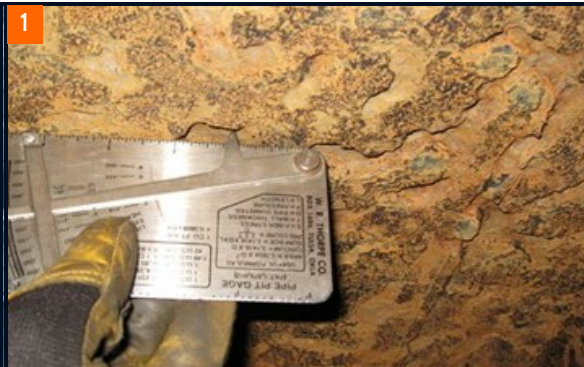
Chemical attack in the vapor space of this drum was evident after 5 years in service.

Corrosion and severe pitting on the inside of a process drum.

1. Severe pitting on the vessel roof
2. Severely corroded vessel to chimney joint
3. Completed chimney stack
4. Completed vessel roof

Application was carried out in accordance with Belzona Know-How System Leaflet TCC-3.

The Belzona® 5891 application was completed in a limited three day time-frame towards the end of a Merox Unit Turnaround.
