# BELZONA 4111 AFTER 15 YEARS

ID: 1172

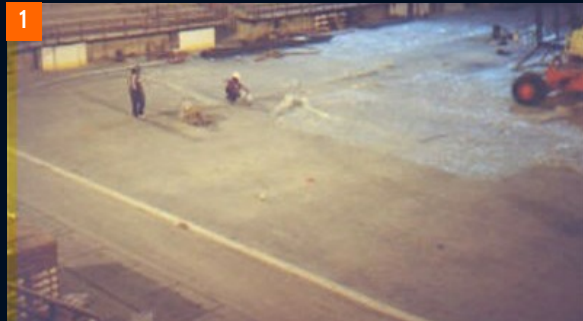
The concrete floor was mistakenly poured 3/4" on top of the anchors for the hockey dasher boards (two sizes, one for the NHL, the other for Olympic events) & circus tie down anchors.

1. Overall view of the floor in 1993
2. Anchor points being chipped out
3. Starting the repairs
4. Typical Belzona anchor 2008

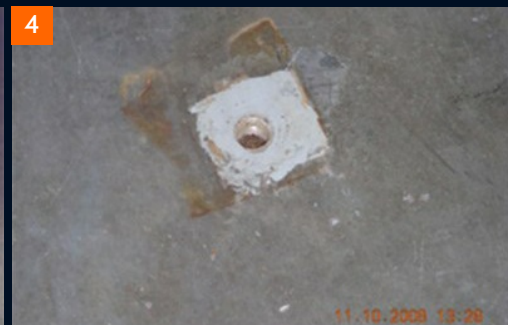
There was no other easy way to restore the floor quickly except replace the entire floor. Previous experience with the building manager & the NHL at another St. Louis location proved that Belzona® 4111 would work. Time was short so that a fast solution was needed to meet the buildings opening schedule. Anchors are still effective 15 years on.
