# OLD APPLICATION MEETS NEW BELZONA APPLICATION

ID: 1174

Diesel shop floor and ramps

Railroad in Saint Paul, Minnesota U.S.A.

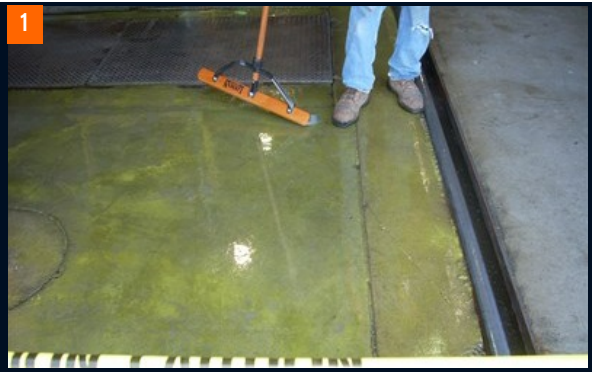
1. Preparing the surface
2. Taping off edges
3. Patching holes before coating
4. Old Belzona 4411 on ramps meets new Belzona 5231 on workshop floor

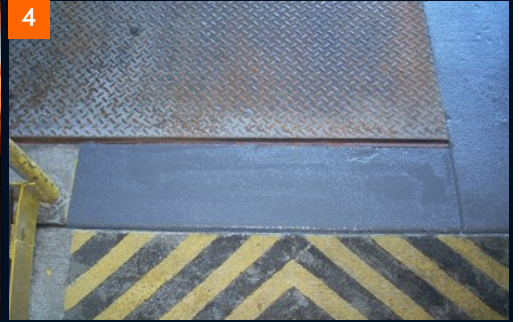
The ramps where done over 12 years ago and still in great condition saving time and money spent re-doing them repeatedly with systems. The floor has shown to be a safety benefit that also is easier and faster for crews to clean.
