# BELZONA SEALS PACKING FACILITY

ID: 1175

Roof was leaking through the seams and joints.

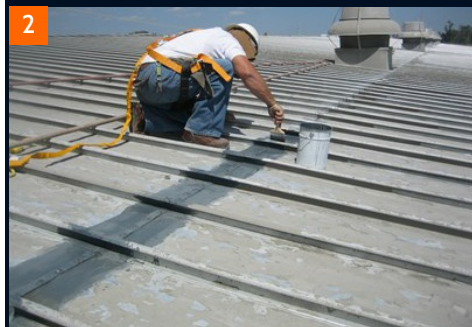
1. Uncoated seams
2. Belzona 3921 (GSC Conditioner) being applied
3. Seams being coated with Belzona 3111 and reinforced with Belzona 9311
4. Finished application.
