# VERY OLD BELZONA TUBE SHEET REPAIR

ID: 1176

This carrier condenser was coated in order to prolong the life of the unit.

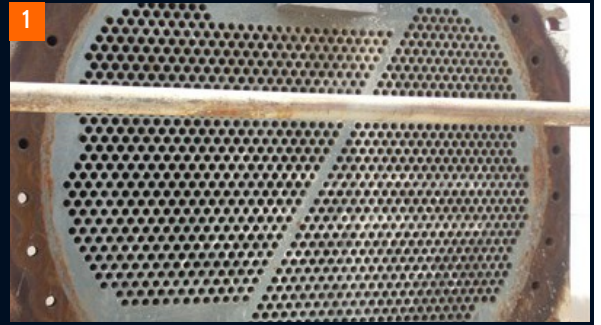
1. Rear of Condenser
2. Close up of sheet
3. Front of Condenser
4. Close up of sheet

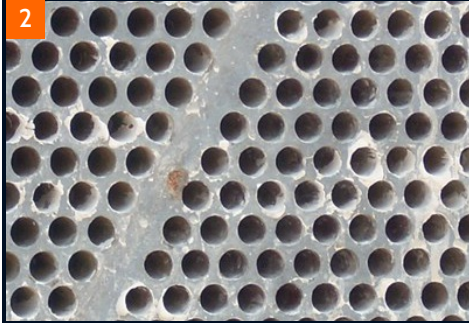
The tube sheet was suffering from bi-metallic corrosion and was in need of protection.

The application was carried out in accordance with Belzona Know-How System Leaflet HEX-1.
