# BELZONA PROTECTS LARGE RIVER PUMP

ID: 1179

Main cooling water pump handling river water.

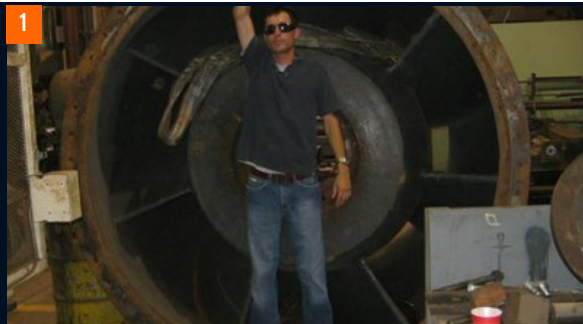
1. Scale of the pump clearly evident
2. Fully restored suction diffuser
3. Work beginning on restoration of impeller
4. Fully protected impeller
