# BELZONA STANDS THE TEST OF TIME

ID: 1180

## PROBLEM

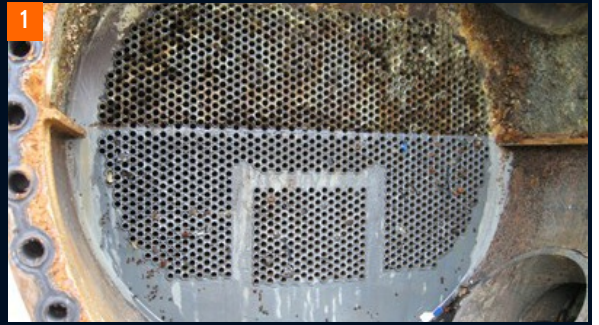
Tube sheet was suffering from bi-metallic corrosion and channel box was suffering from erosion/corrosion.

1. Bi-metallic corrosion tube sheet
2. Existing Belzona repaired blasted and channel box coated for first time
3. Fully restored tube sheet with second application of Belzona
4. Rear of chiller shown fully corked and coated, waiting for corks to be removed

Rebuild and protect the tube sheets on the faces of chiller. Also returned five years later for customer to inspect and to coat the channel box and baffle.
