# BELZONA REBUILDS AND PROTECTS EXHAUST ON YACHT

ID: 1181

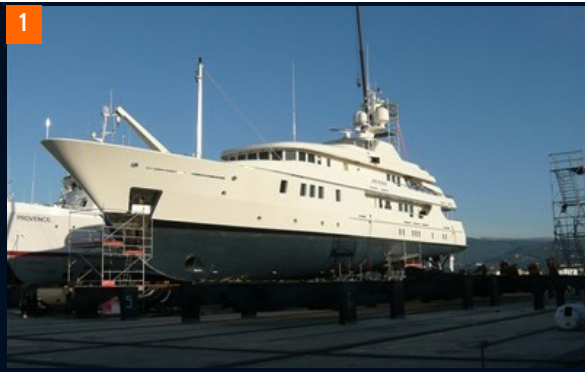
Severe corrosion caused by hot exhaust gas and salt water, led to critical loss of steel.

1. The yacht in dock
2. Initial state of exhaust pipe
3. Pitting clearly evident after blasting
4. Final result after rebuilding with Belzona 1511 and coating with Belzona 1391

Belzona 1511 (Super HT-Metal) Belzona 1391 (Ceramic HT)
