# BELZONA RESTORES AND PROTECTS RIVER WATER PUMP

ID: 1182

Cooling water pump drawing water from the Mississippi river.

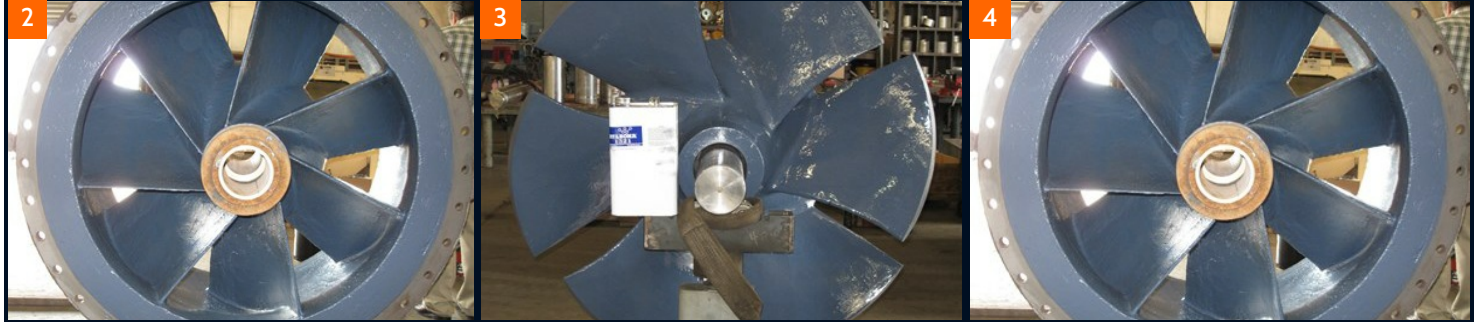
Pump was experiencing corrosion and cavitation erosion damage. Much of the casing was suffering from pitting caused by impingement.

1. Rebuilt and protected suction bell
2. Impeller with first coat of Belzona 1321 (Grey)
3. Impeller fully protected with second coat Belzona 1321
4. Suction diffuser fully restored

Application was carried out in accordance with Belzona Know-How System Leaflets CEP-1, -3 and -5.

Belzona 1111 (Super Metal) Belzona 1321 (Ceramic S-Metal)
