# BELZONA 1511/1591 TAKE THE HEAT

ID: 1183

The LP turbine flange on a steam generator turbine.

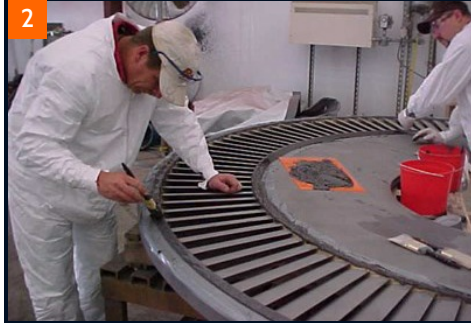
Steam cuts in the metal diaphragm. Welding would distort the flange and a short outage caused them to come to Belzona for an unconventional alternative.

1. Eroded flange before repairs
2. Belzona 1511 being used to build back the edges and steam cut areas
3. Belzona 1511 built back to original profile and ready to machine
4. Belzona 1591 coated after the two pieces put together for machining

Belzona® 1511 used to rebuild damage (up to 1/2"), then machined to profile before coating with Belzona® 1591.
