# BELZONA PROTECTS CONDENSOR JOINT FOR TWENTY YEARS

ID: 1184

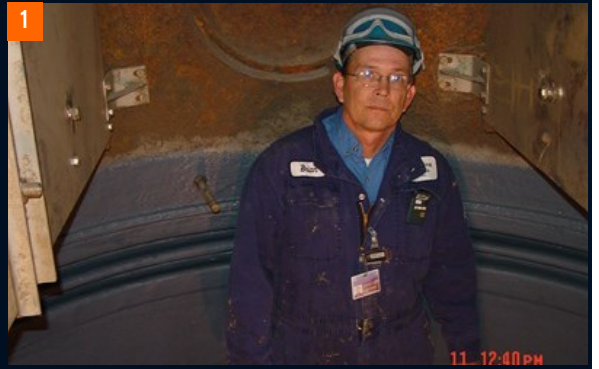
1. The original repair
2. Overall view of the repair
3. Rebuild with Belzona 1311
4. Two coats of Belzona 1321 applied over the joints

First repair lasted 20 years. Although the unit had been down 10 of those years. When the unit was restarted the engineers inspected the old Belzona and found it in excellent shape with only minor damage. It was decided to remove the old Belzona and rework the project. A dozen joints were repaired and coated.
